Manhole Inspection Summary

Manhole # S13GG2013MH

Insp Date: **6/30/06 9:18 AM**

Location Address: **5911 BONNIE VIEW DR**

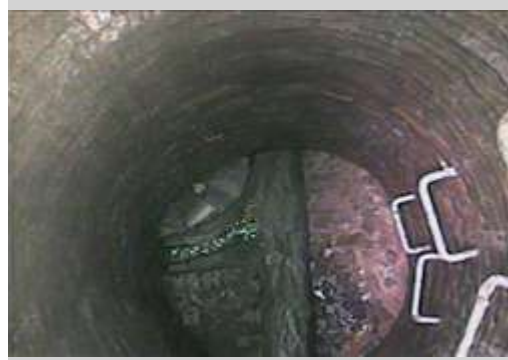
Top View

☒ **Debris** (not Condition related)

☒ **Evidence Of Surcharge**

Depth: **1** (ft.) ☐ Active Surcharge Present

Evidence of surcharge - Bench debris.

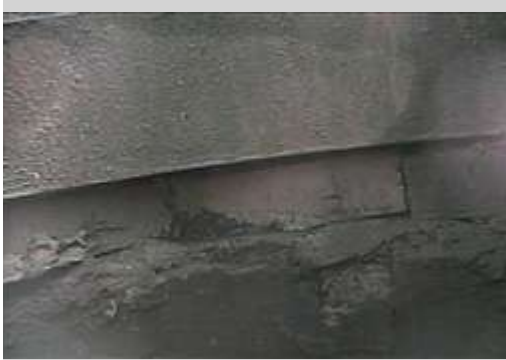
Defect

☒ **Leaks**

Infiltration: ☐ None ☒ **Joint** ☐ Cracks ☒ **Mortar** ☐ Roots ☐ Wall

Frame leaks. Adjustment infiltration.

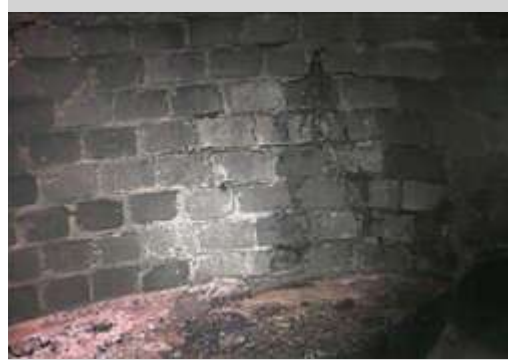
Defect

Infiltration: ☐ None ☐ Joint ☐ Cracks ☒ **Mortar** ☐ Roots ☒ **Wall**

Barrel infiltration.

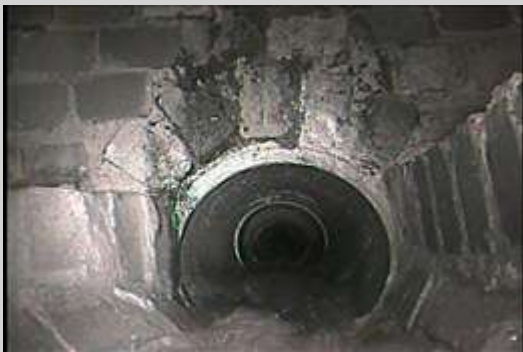
10 in. Circular Gravity Sewer Pipe Out @ 12 O'Clock

Infiltration: **Evidence** Pipe Seal Cond: **Unknown**

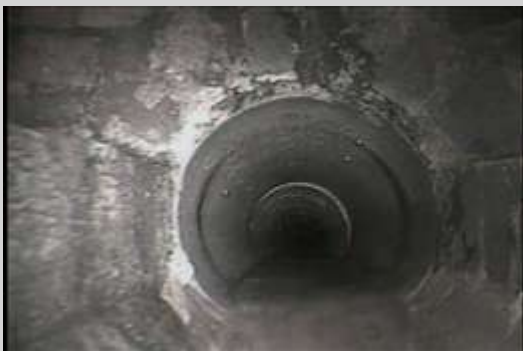
10 in. Circular Gravity Sewer Pipe In @ 6 O'Clock

Infiltration: **Evidence** Pipe Seal Cond: **Unknown**

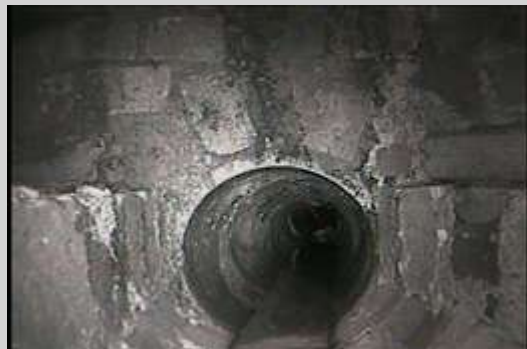
Pipe In @ 9 O'Clock

Infiltration: **Evidence**
